SOUND HOME INSPECTIONS

April 3, 2009

Re: 1101 McKenzie Ave. Bellingham. Washington

The following is my report about the site visit to the property sited above, commonly known as the Young Building. This report is also based upon the photos taken during my visit and some documents that you provided subsequent to that date.

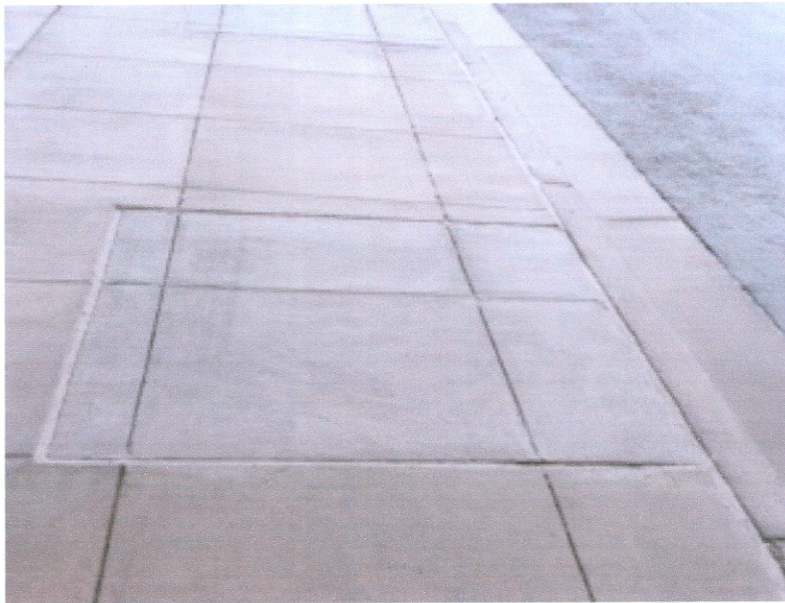
The original design and your report show some street tree areas. There are also some signs of water stains and current water intrusions. The planned-for tree areas have now been eliminated but this doesn't appear to have solved the leak problems.

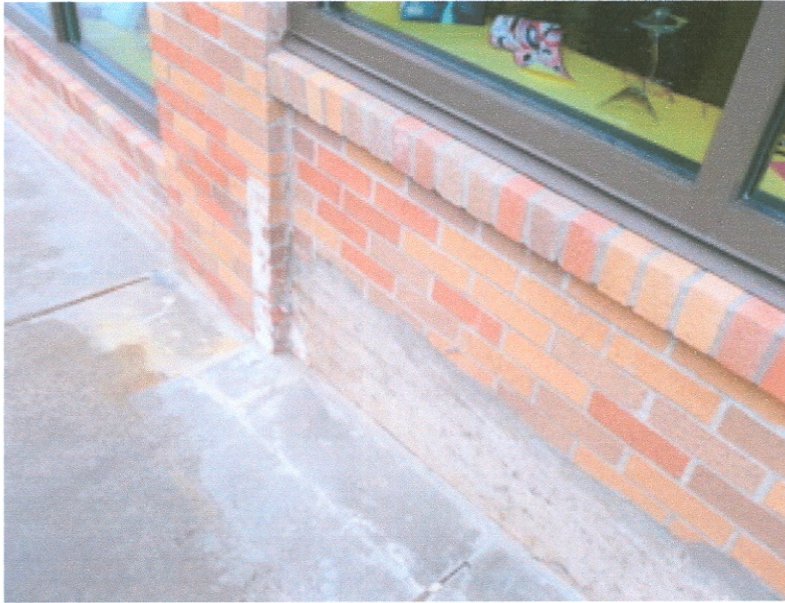
There are a number of areas with caulking and other modifications at the sidewalks, the intersection between the building structure, the entrances and walkways. Planters and/or brick siding details have been eliminated. Some of the brickwork repairs have been started and some mortar and caulking modifications are apparent. Most of this work appears to be incomplete and some of the work is sub-standard.

For example the brick and mortar modifications are messy and uneven.
Active leaks are evident in the garage ceilings under the areas with sub-standard work.

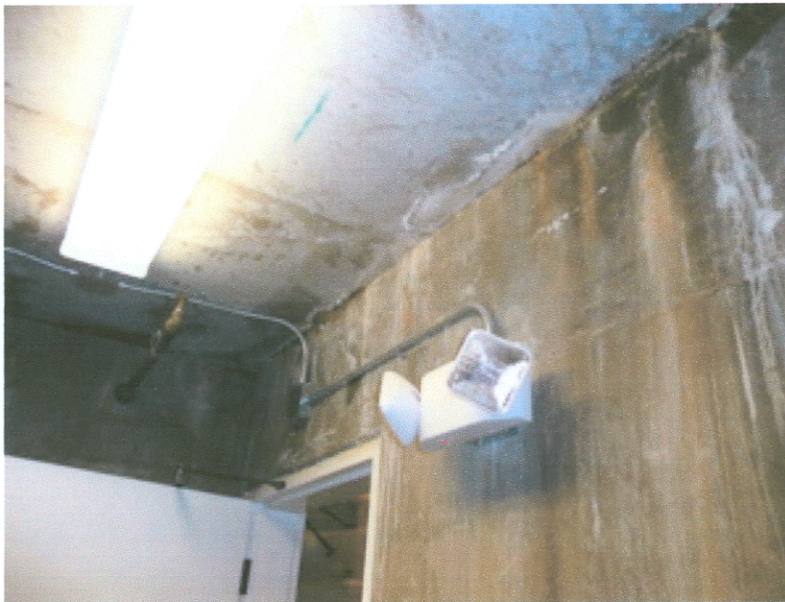
The photo (immediately above) shows an area at the east side of the Young building. The leaks here appear to be related to moisture entry at the patio between the two buildings. These leaks appear to be active and are likely to damage the doors and frame and the electrical lines and fixtures.

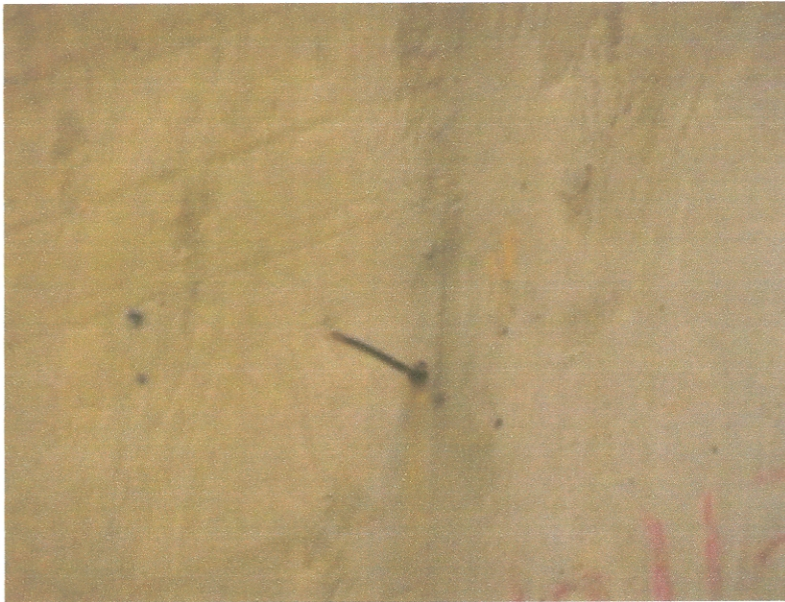
The photo above shows one of numerous form ties similar items that should have been trimmed during the finishing portions of the construction. There are also some areas with pieces of wood concrete-form material that have not been removed and areas of uneven concrete surfaces that should have been corrected.

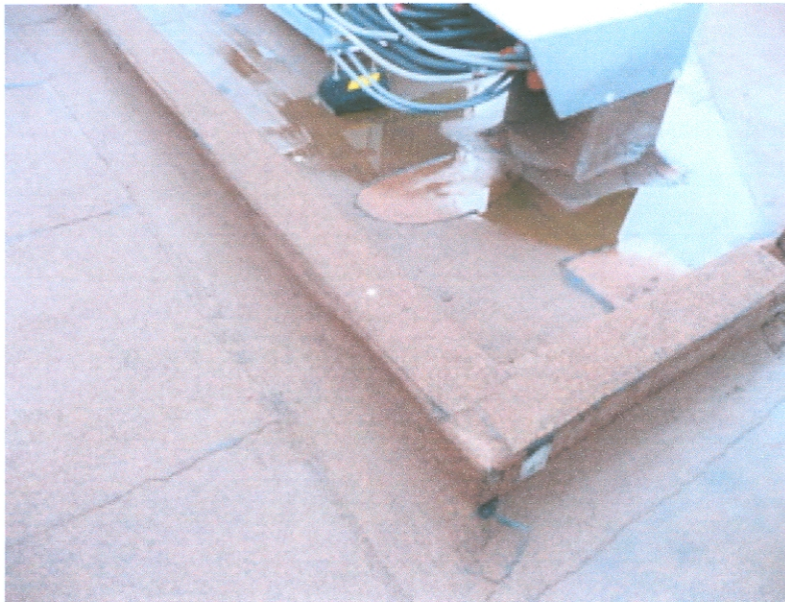
The photo (above) shows an example of several patches and short roofing caps that don’t extend over the edges of the “parapets.” It also shows one of the HVAC roof penetrations with messy use of foam sealant in place of a cap that would prevent water penetration.

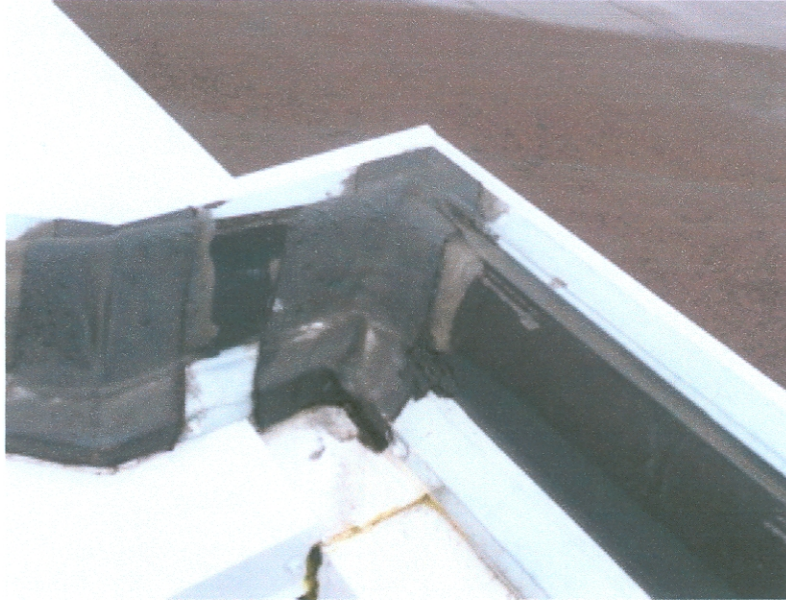
This photo (above) shows one of several areas at the expansion joint caps with one or two generations of repair. These caps are designed to cover airspaces between structural elements in the building. Leaks at such locations could travel several floors down and into the building and garage structure. The absence of roof venting systems could aggravate this problem.

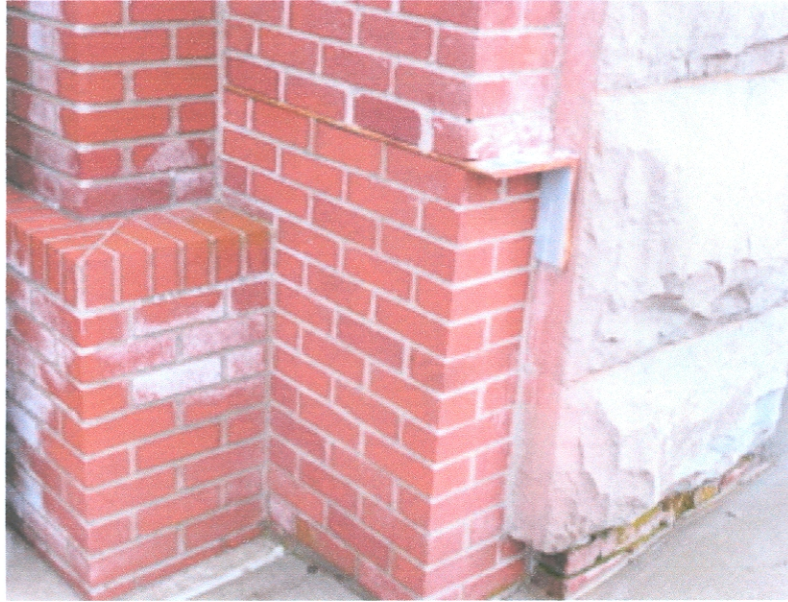
As noted above, some of the brickwork has been modified in a sub-standard manner. I also noted some incomplete and damaged brickwork. For example, the photo below shows one of the areas of exposed metal “lintels”, in this case with a sharp edge at the southwest corner of the Waldron building. This sharp corner is in a foot traffic area. This photo also shows some areas in need of mortar repair and cleaning.

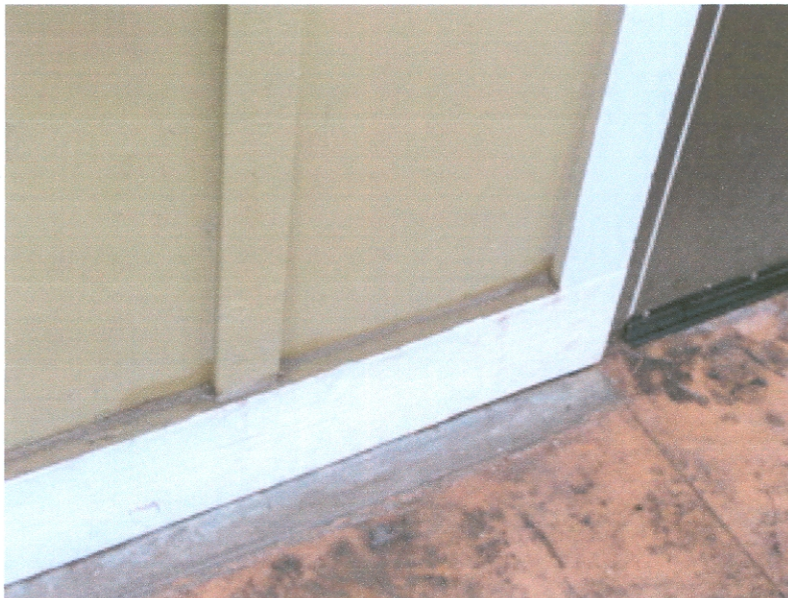
The photo (below) shows an example of trim material that was not capped with flashing. As seen in this photo, water accumulates at the top of the horizontal (white) trim material. Flashing is the workman-like manner to prevent water penetration and damage at such locations. The use of caulking to take the place of the flashing is a sub-standard practice.

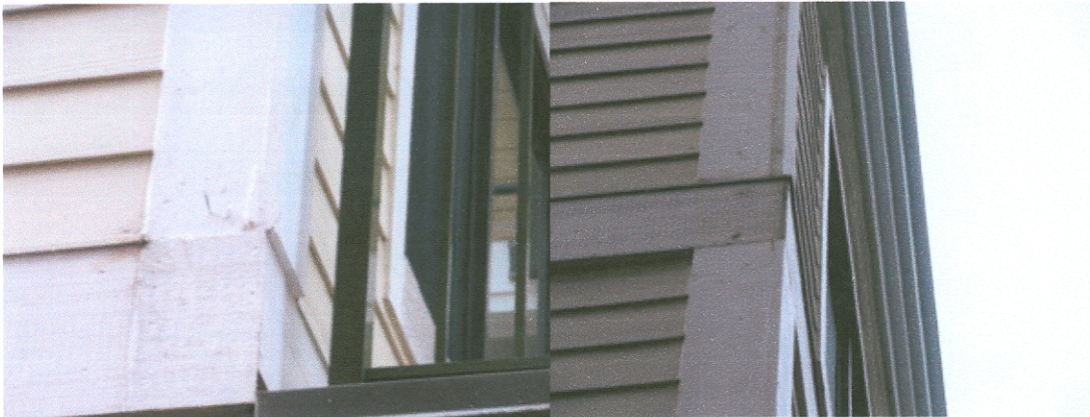
The photo (below) show some inconsistent and other defective trim and flashing practices. The photo on the right shows continuous flashing at the top of the “belly”

board. In the photo the left flashing is interrupted (a short piece) on one side and is missing on the other.

Workman-like trim, siding and flashing details are very important and a part of the manufacturers' specifications and standard practices for this type of siding. Similar practices are required in most other types of siding. Defects of the type noted here are often associated with exterior envelope failure.
